# Research Report

## 20151540-E

Subject matter: Comparison of tensile strength and fatigue limit of chipless repaired threads to new threads

Test object: threaded stud M8 x 300 made of 1.5510 (28B2)

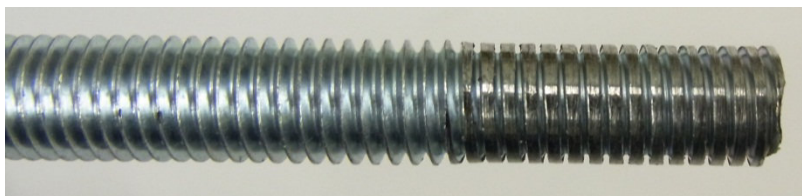
The tensile test has been done due to DIN EN ISO 898-1 and listed in table 1. In order to test damaged threads one side of the threaded stud was damaged as shown in figure 1 (the first 15 pitches were damaged on the entire circumference). These damages have been repaired by „Silbertool R16“ so that the threads were fully formed back and fit for use as shown in figure 2. Thereafter 12 pitches of the threaded studs were screwed into the testing device.

**Figure 1: damaged thread**

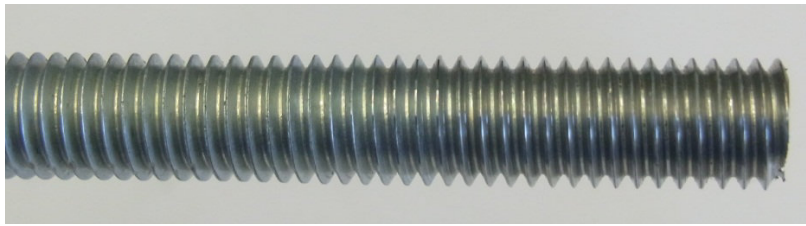
**Figure 2: repaired thread**

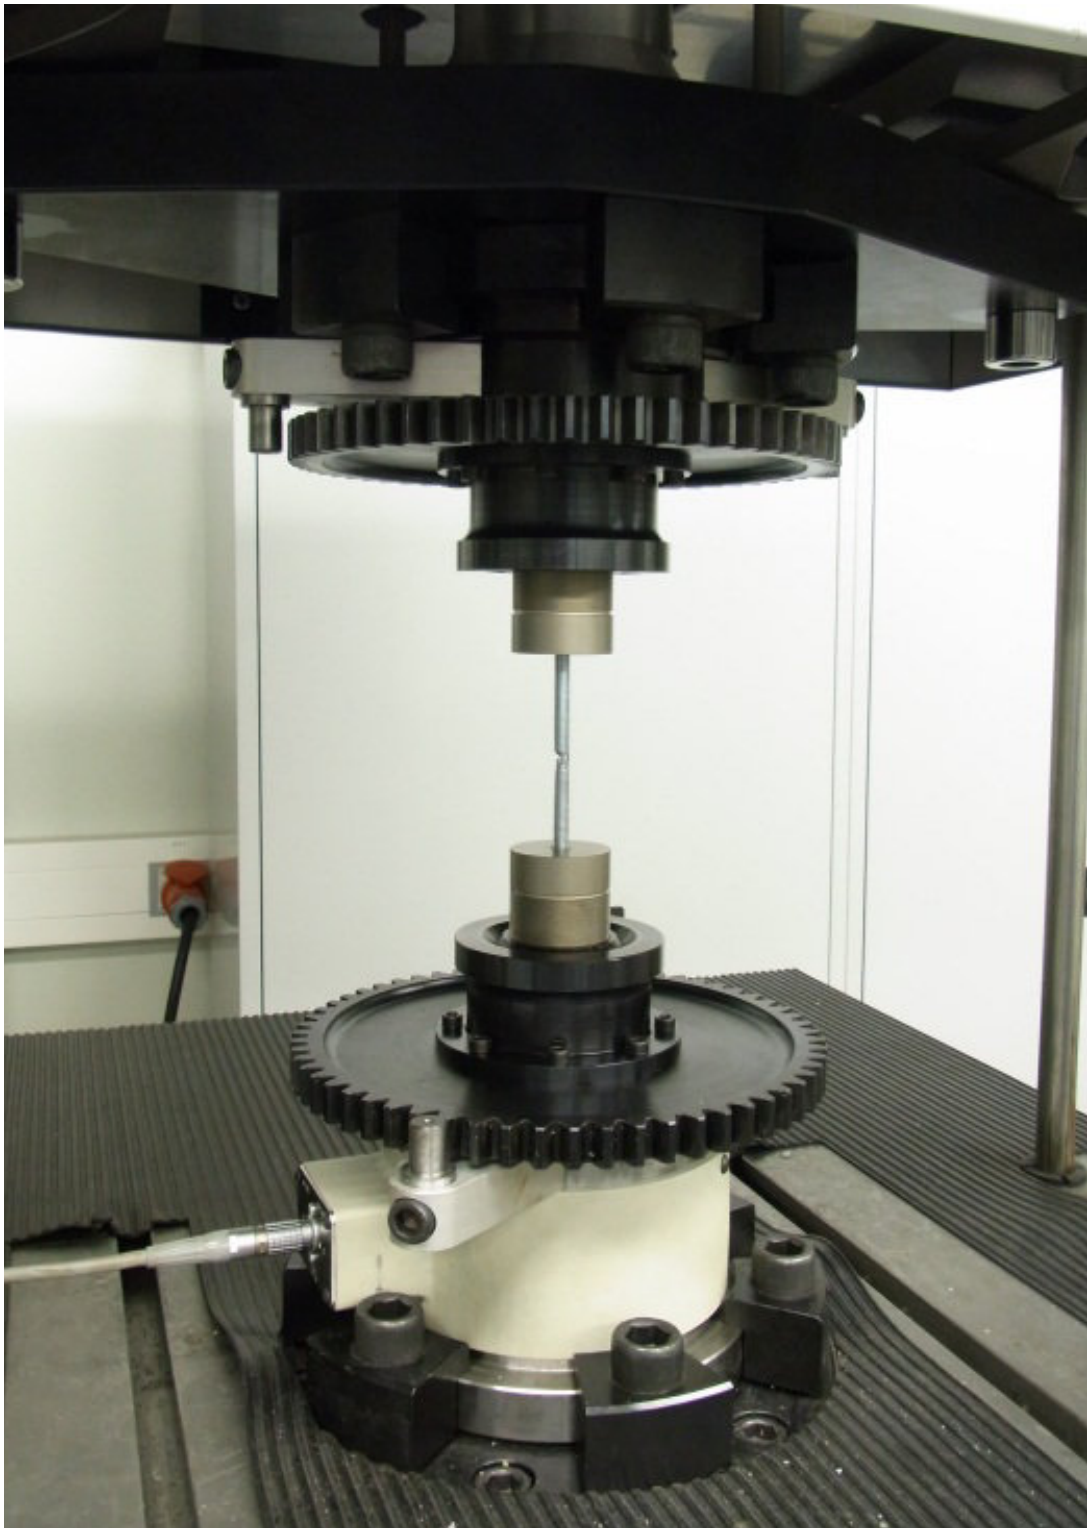
The tensile test of both test series give equivalent test results (see fig. 4 and fig. 5). Fractures which lead to failures always occurred on the free loaded thread as shown in figure 3.

In both test series the required minimum break force due to DIN EN ISO 898-1 (2009-08) was exceeded and the bolted threads were not been damaged.

**Figure 3: Failure after tensile test**

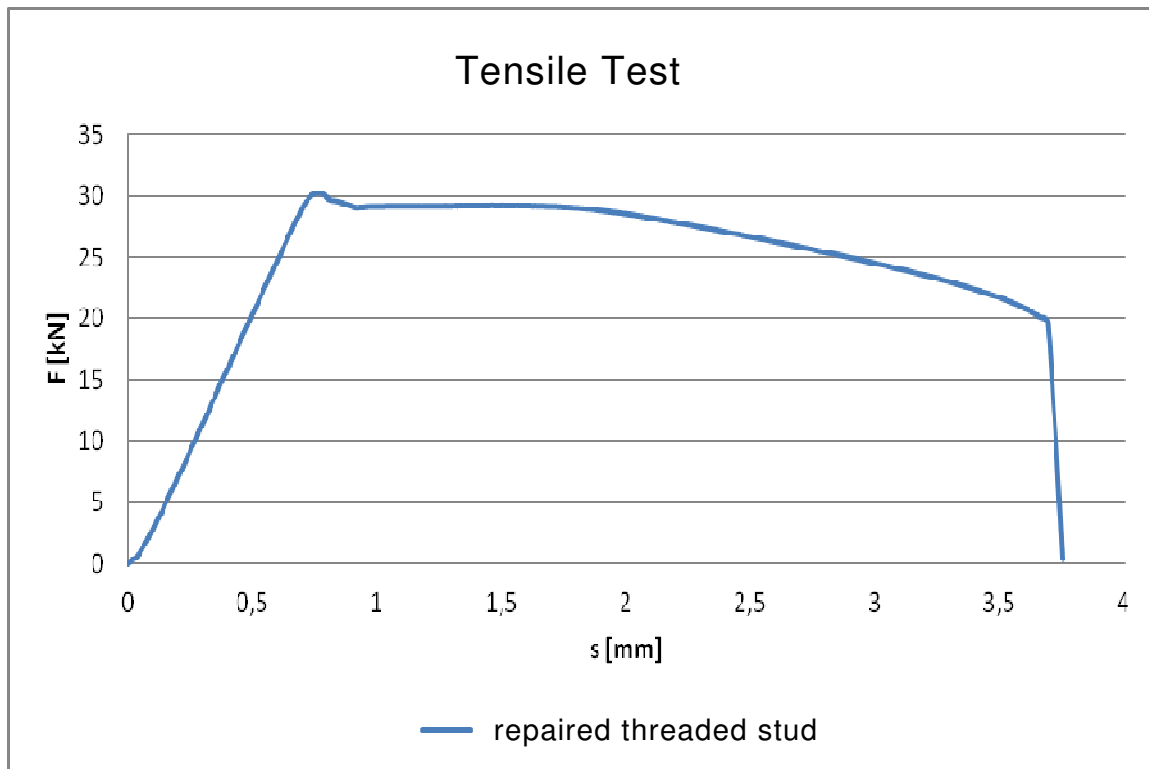
**Figure 3: Tensile test of a repaired thread stud**

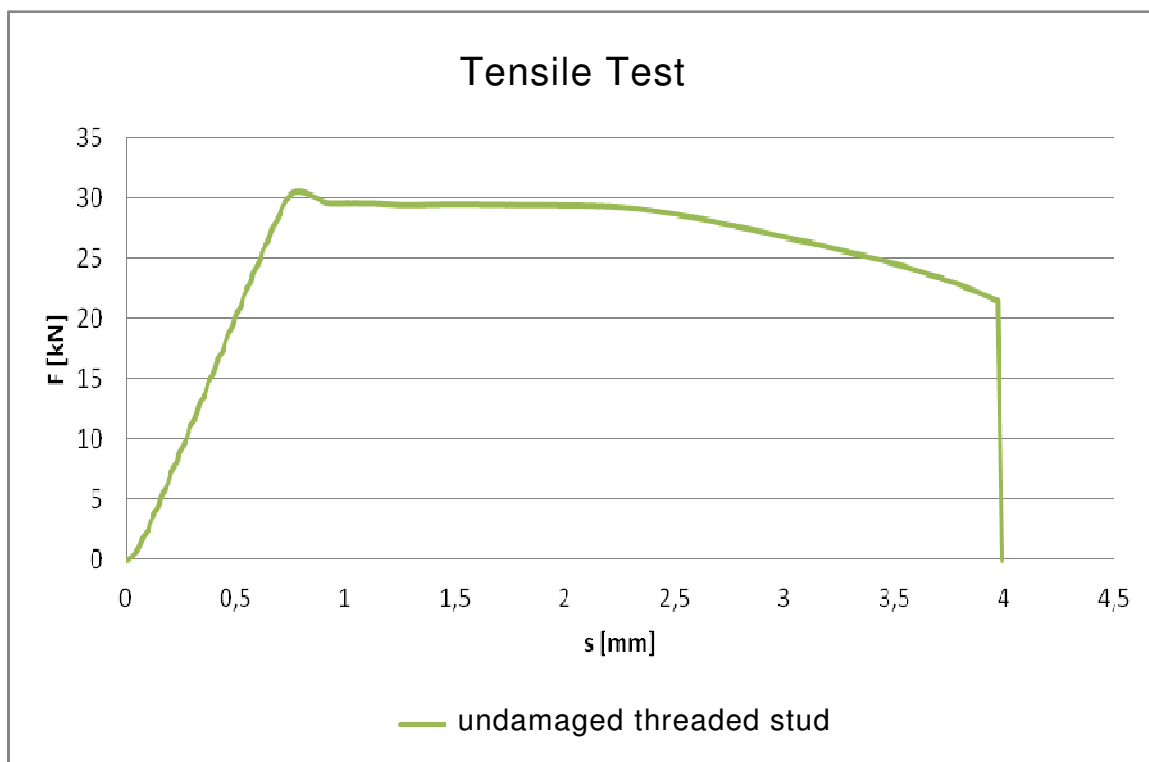
**Figure 5: Tensile test of an undamaged thread stud**

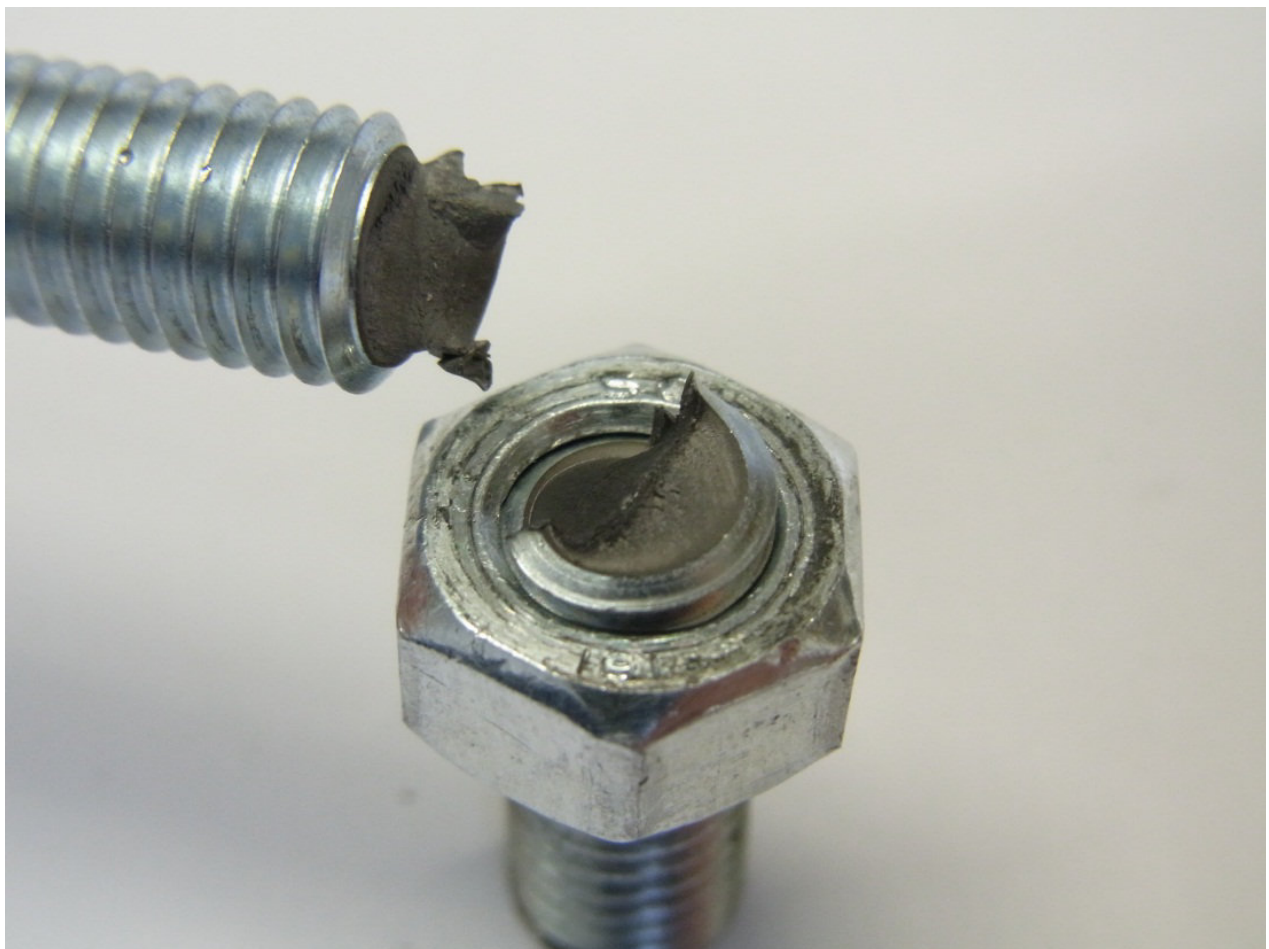
In order to compare the fatigue limits of an undamaged thread and a repaired thread directly the threaded stud was damaged and repaired again on one end. Afterwards it was screwed into the testing device. A fatigue fracture occurred only on the undamaged (new) end of the threaded stud, not at the repaired end (see fig. 6). Following a validation of this result has been done by testing entirely new threaded studs. The failure fatigue occurred after appr. 15,000 cycles too (see fig. 7).

Figure 6: Fatigue failure of a threaded stud M8-8.8 in first carrying pitch

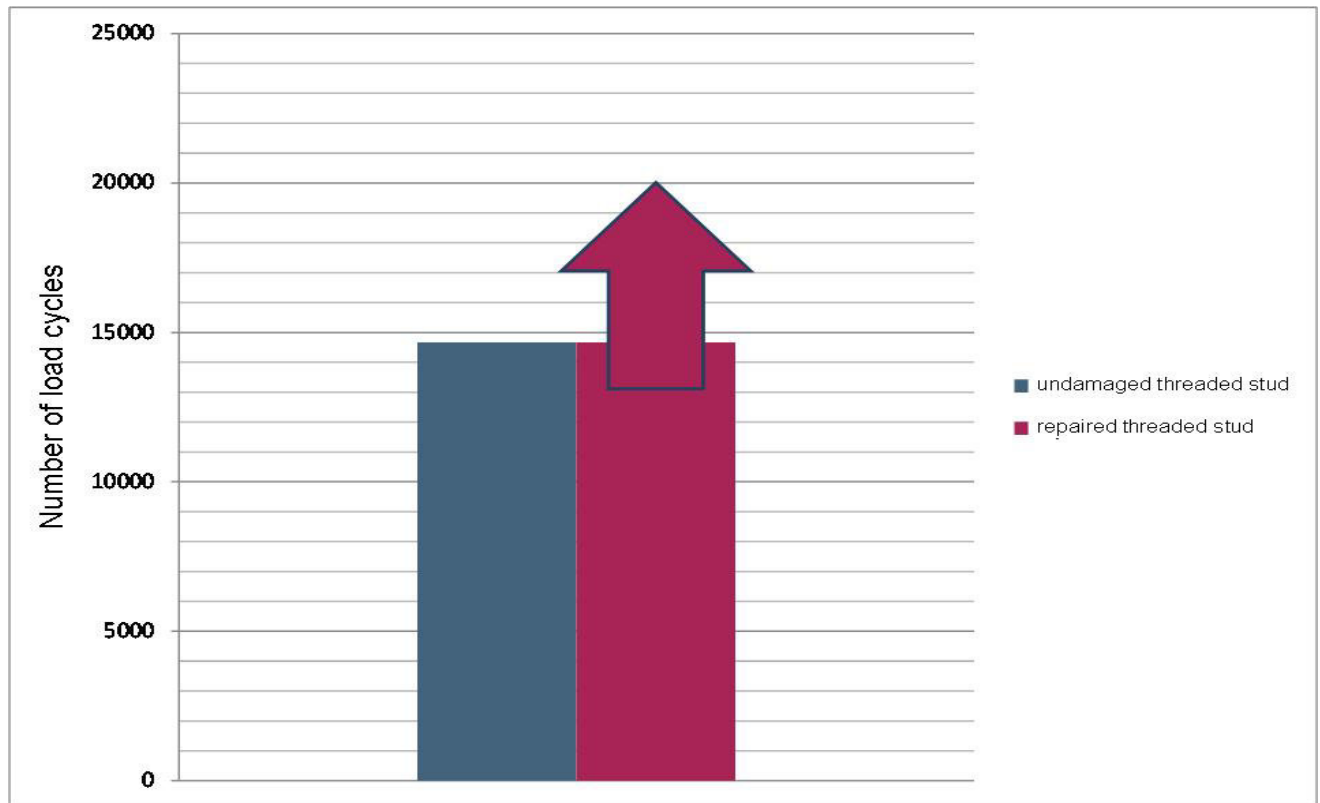
Figure 7: Comparison of fatigue strength of a thread repaired by SilberTool®-procedure with an undamaged thread

A repair by using SilberTool®-procedure does not have a negative effect on the static and dynamic stability of the thread. All obtained results match the required standard values given in DIN ISO 898-1. Threads which have been repaired by SilberTool®-procedure have shown within the tests a higher fatigue limit than new threads. By using the SilberTool®-procedure the threads surface is burnished and the materials surface is cold work hardened. A quantitative conclusion concerning positive effects on fatigue limit has to be ascertained in separate experiments.
